Debris/Ice/TPS Assessment and Integrated Photographic Analysis of Shuttle mission STS-112

**DEBRIS/ICE/TPS ASSESSMENT and
INTEGRATED PHOTOGRAPHIC ANALYSIS
OF SHUTTLE MISSION STS-112**

Armando Oliu
Process Engineering/Mechanical System Division/ET-SRB Branch,
Kennedy Space Center, Florida

October 7, 2002

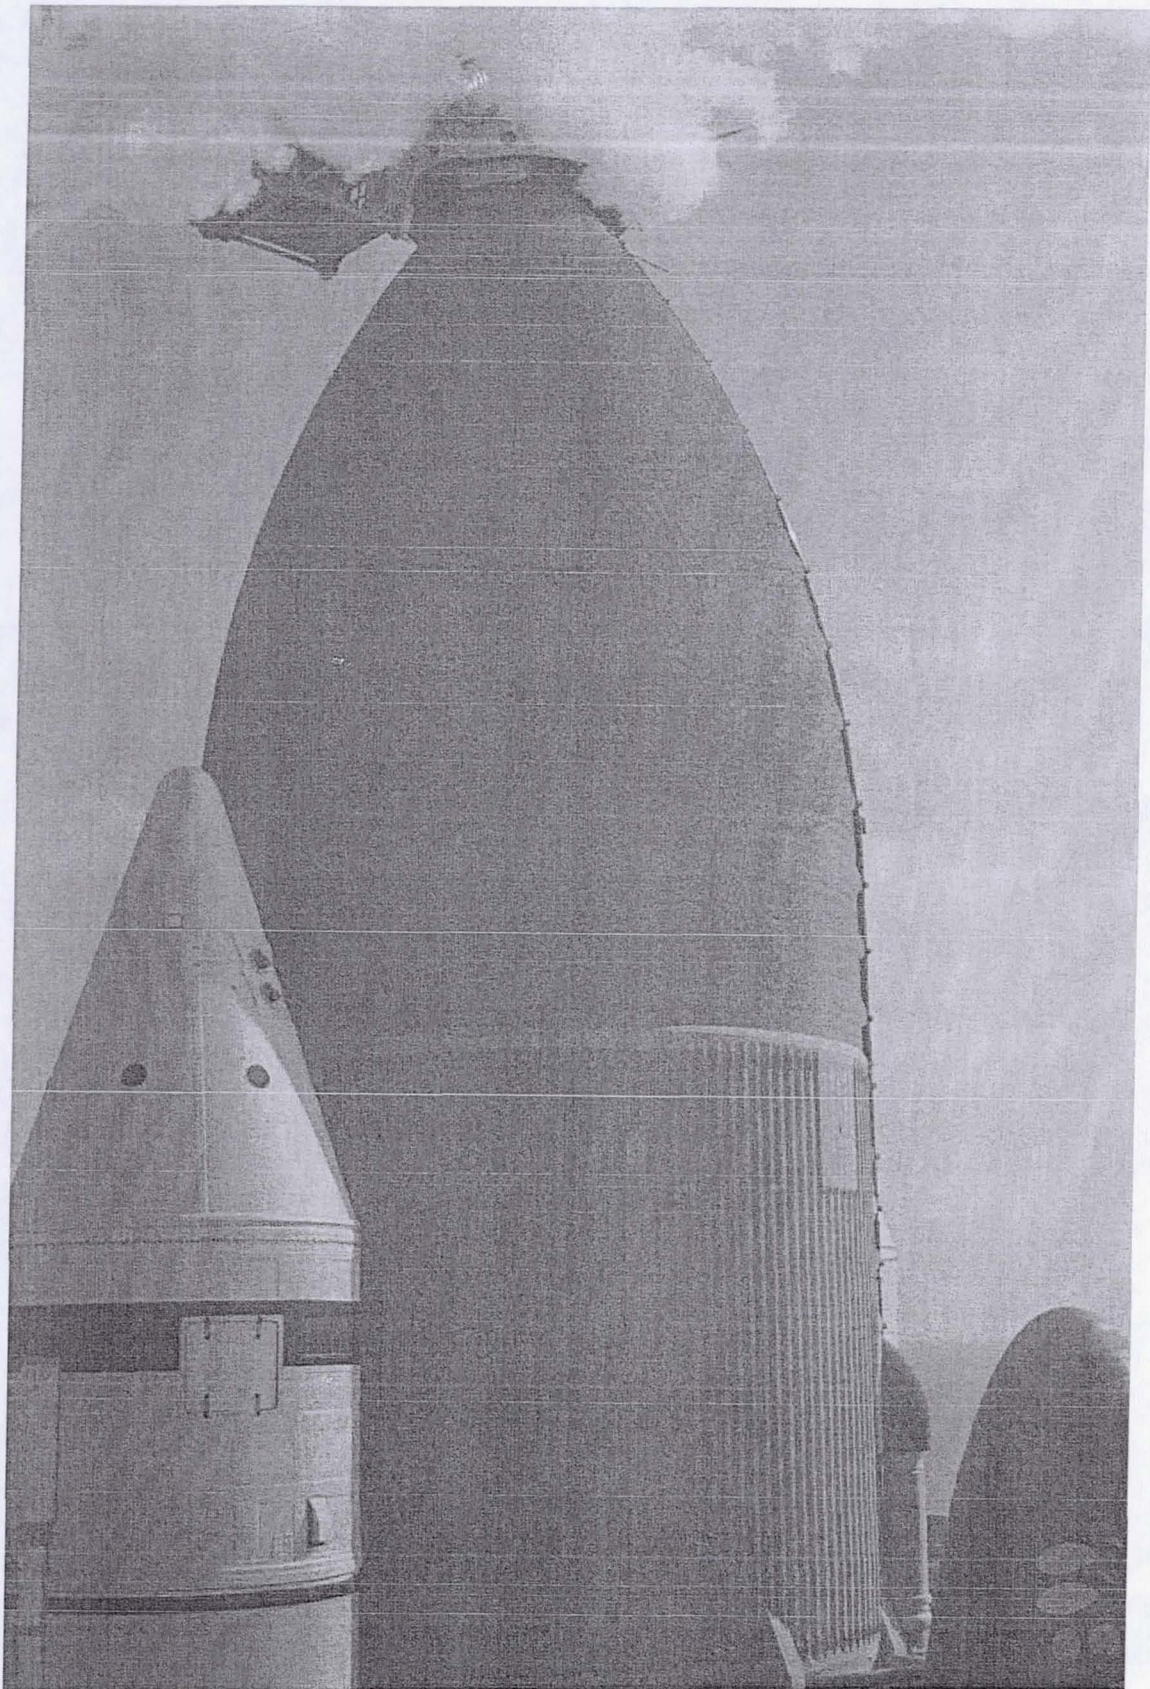
Photo 2: LO2 tank acreage.

Moderate condensate was present on the LO2 tank acreage. Surface temperature ranged from 65 to 70 degrees Fahrenheit. There were no acreage TPS anomalies.

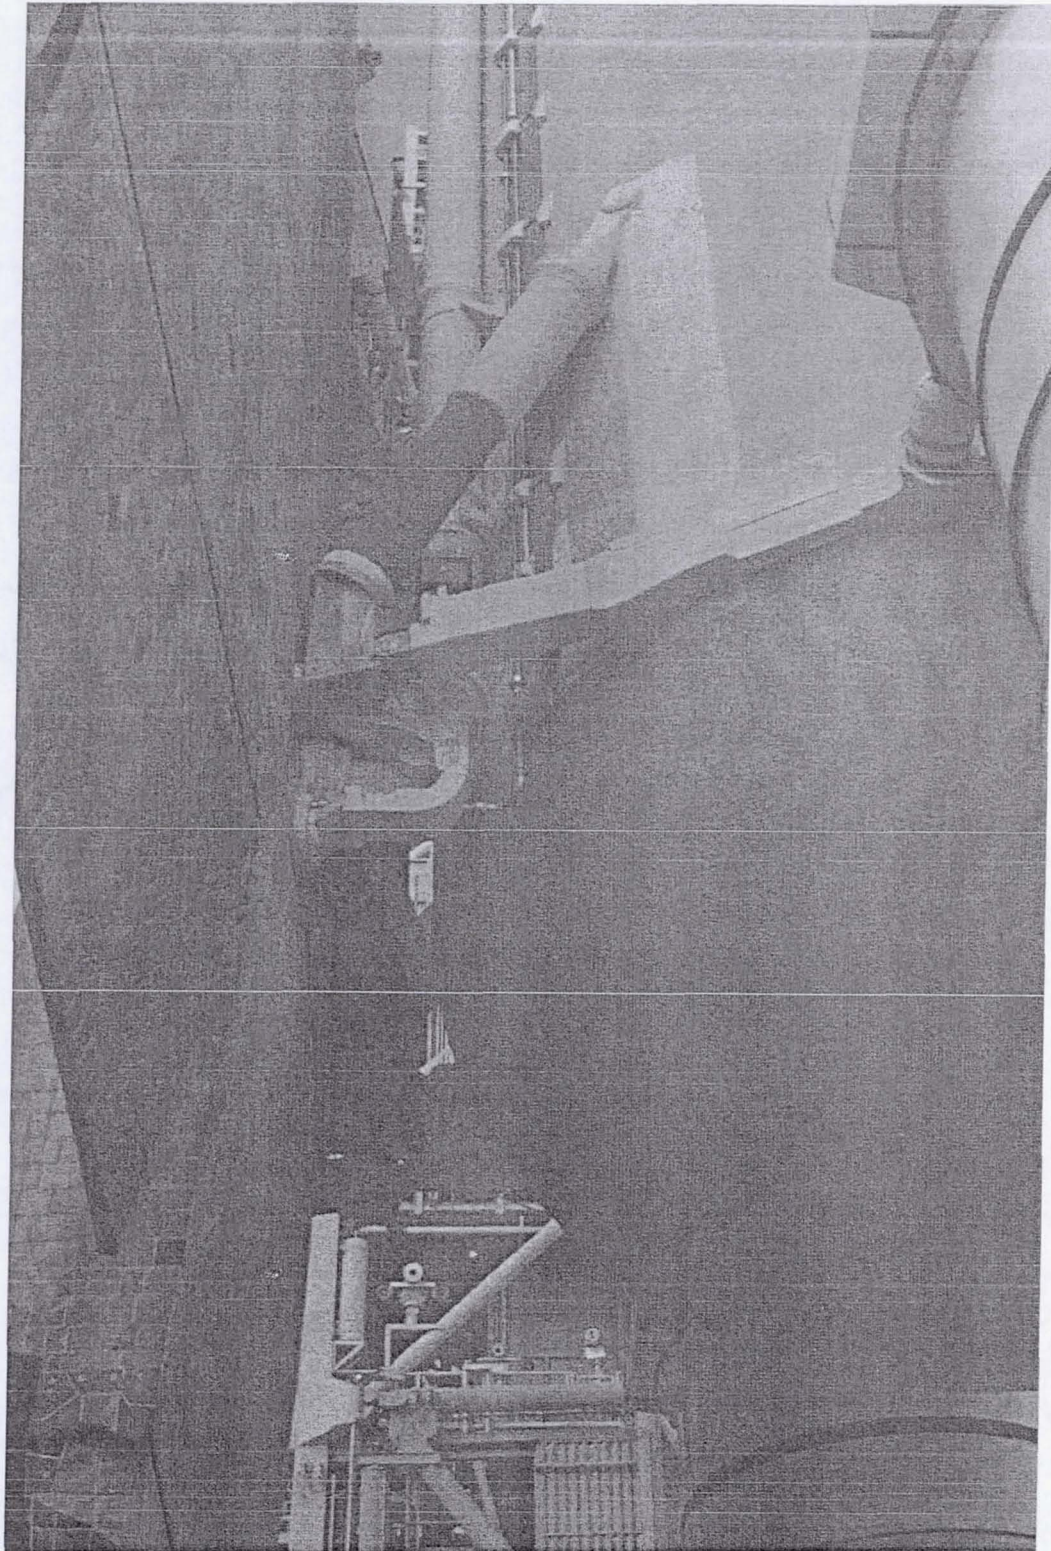
Photo 3: LH2 tank acreage.

Light to moderate condensate was present on the LH2 tank acreage. Surface temperature ranged 65 to 70 degrees Fahrenheit. There were no acreage TPS anomalies.

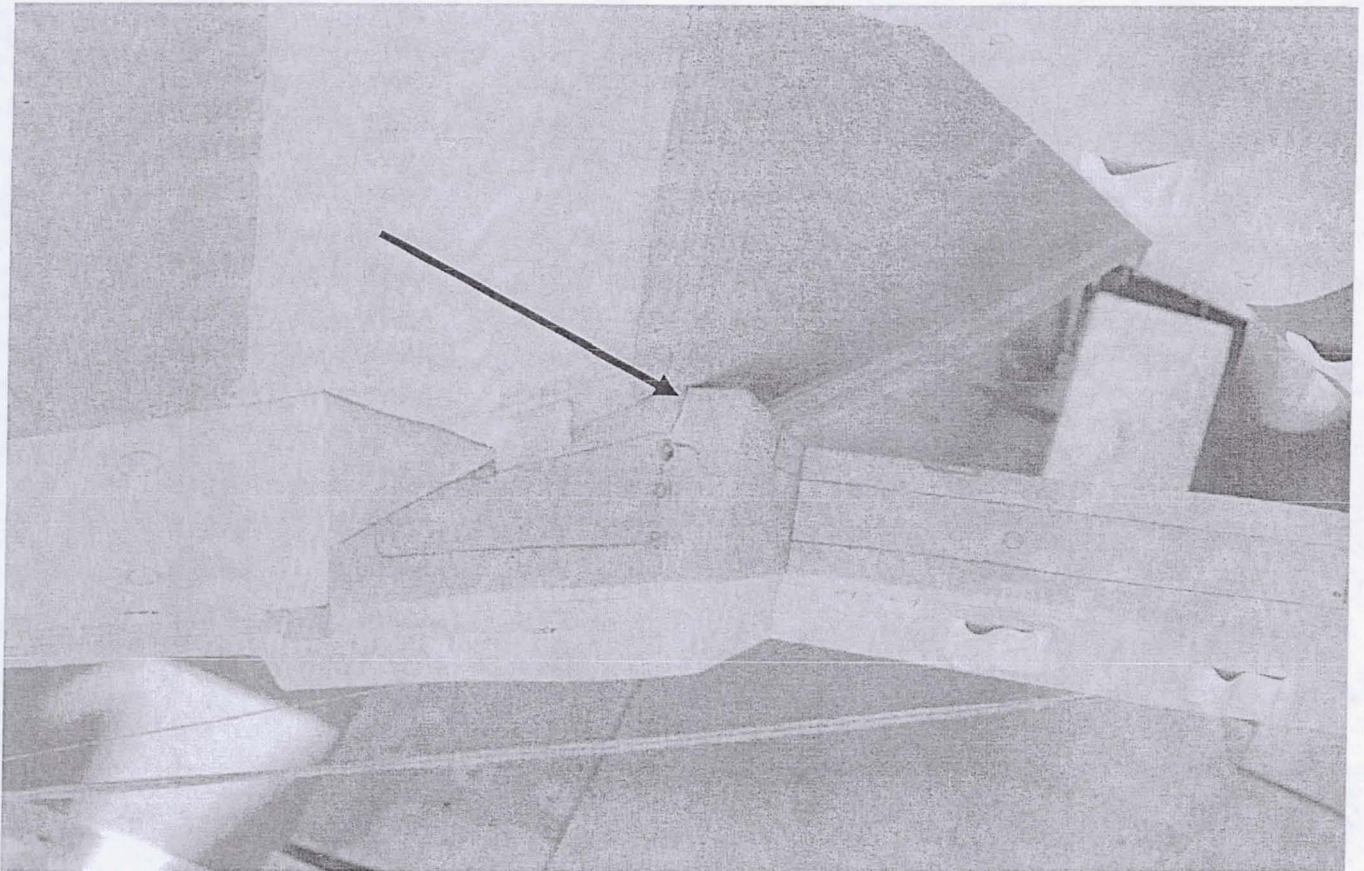
Photo 4: Crack in -Y Vertical Strut TPS

A 7 inch long and 1/4 inch wide stress relief crack was observed in the -Y vertical strut TPS with no offset. This condition has been observed on previous vehicles and found acceptable for flight per the NSTS-08303 criteria.

An 7 inch long and 1/4 inch wide stress relief crack was observed in the -Y vertical strut TPS with no offset. This condition has been observed on previous vehicles and found acceptable for flight per the NSTS-08303 criteria.

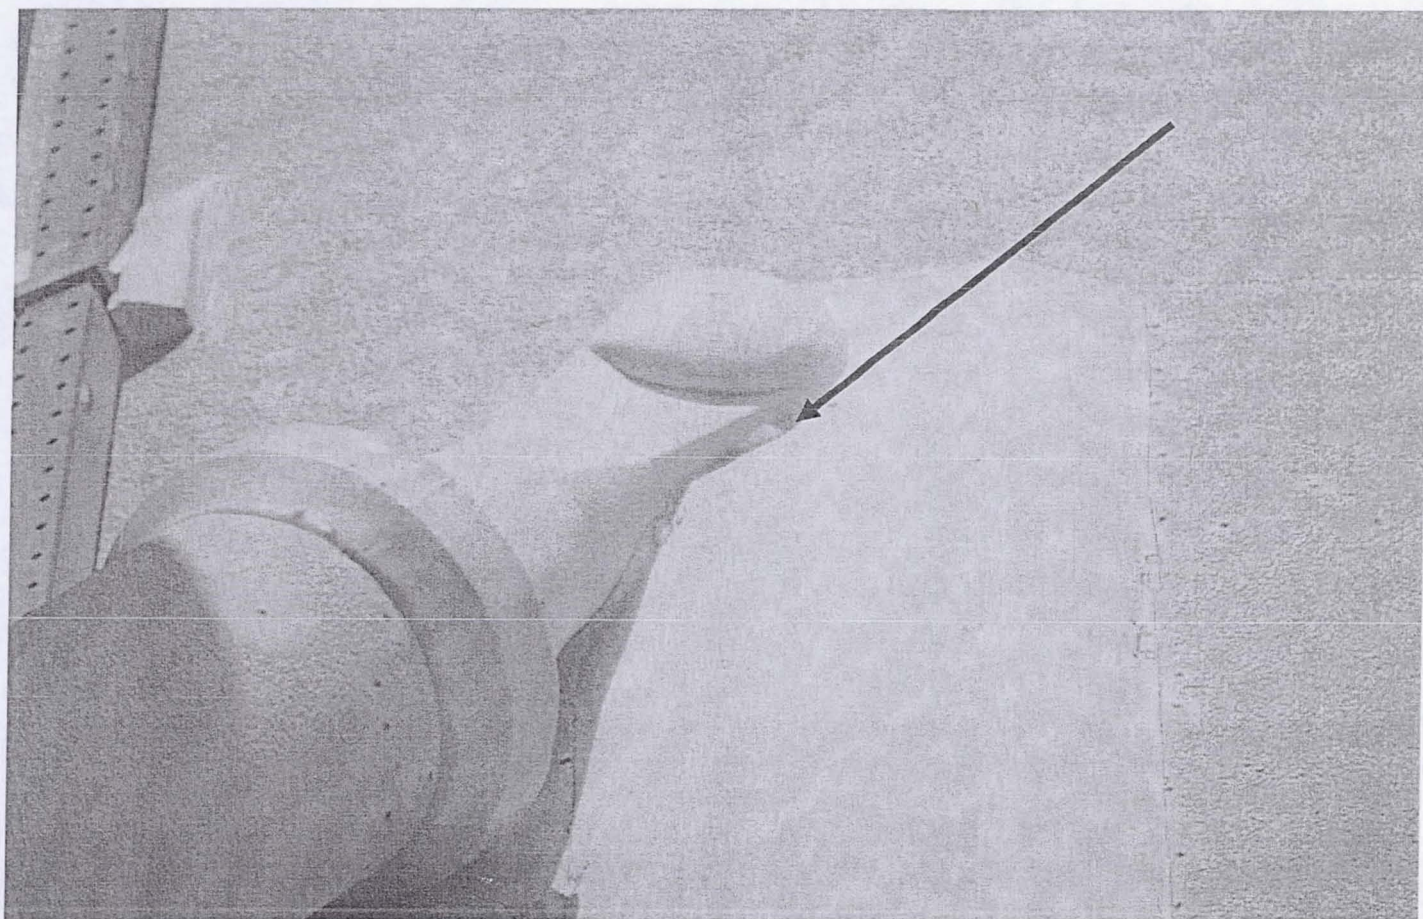
Photo 5: Frost in knuckle of thrust strut to longeron interface.

This is a light frost formation and acceptable per NSTS-08303.

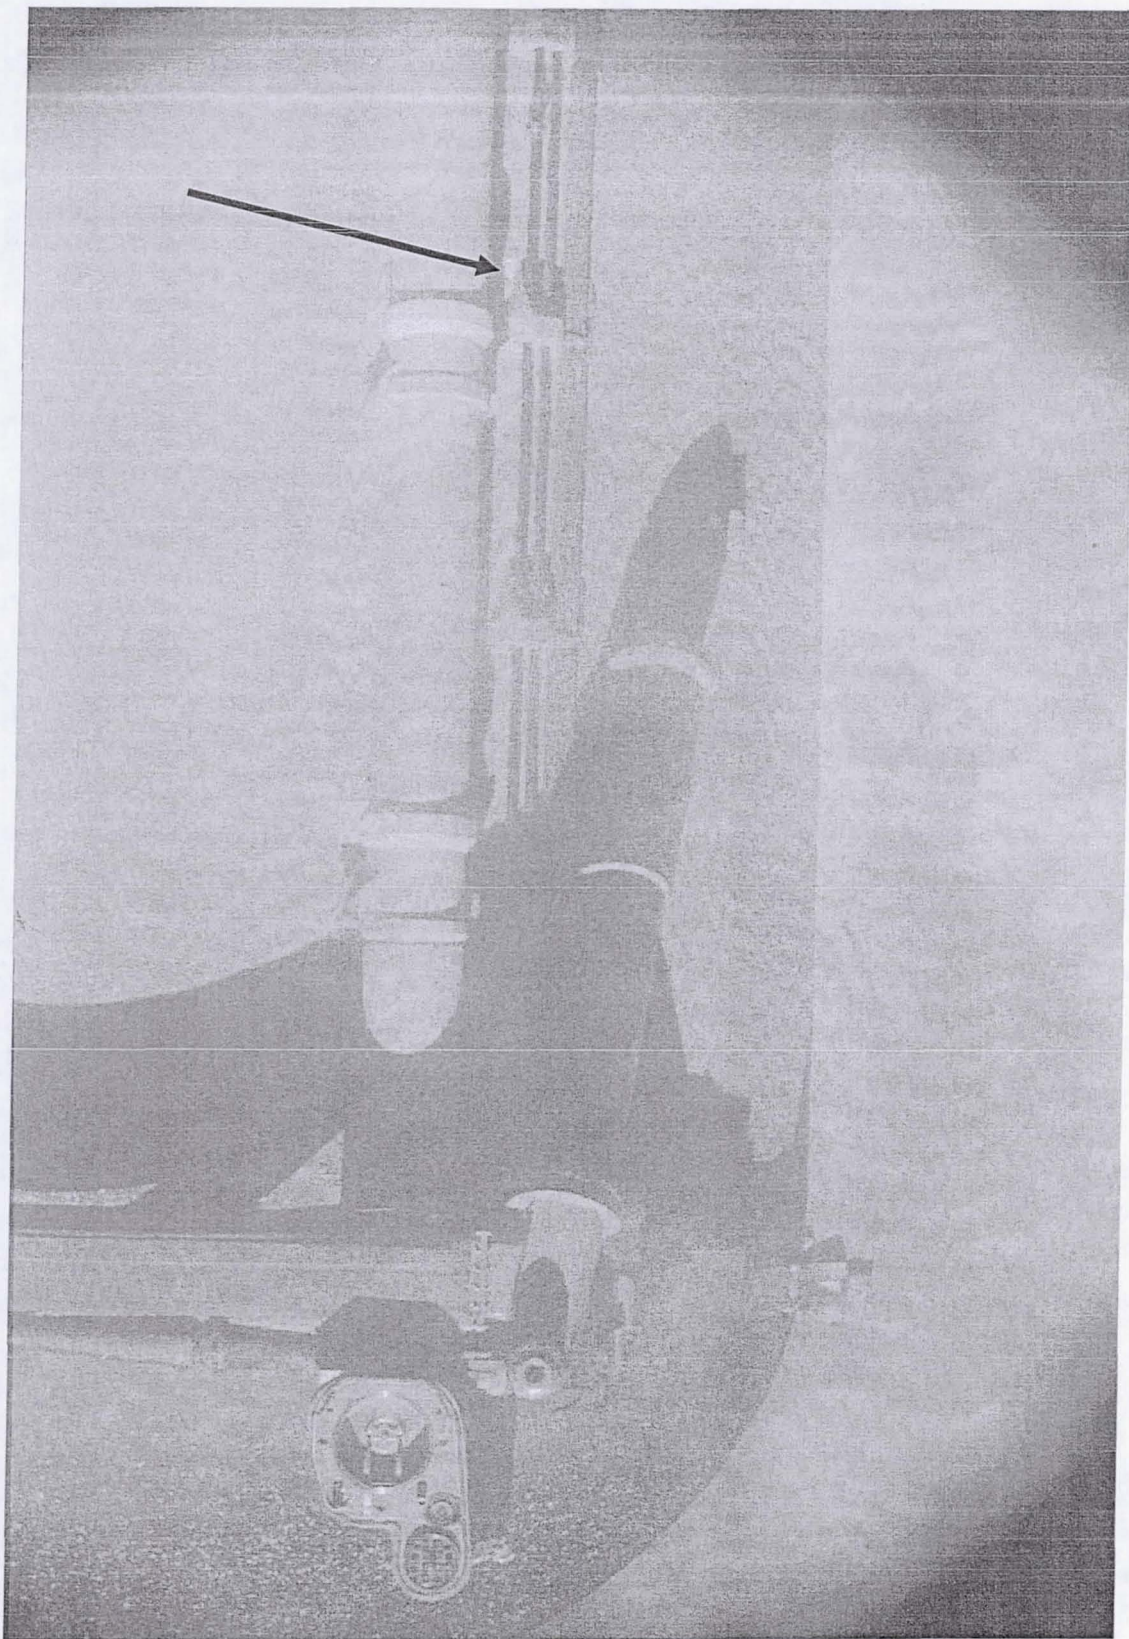
Photo 6: External Tank post separation

One shallow TPS divot was observed on the LH2 tank near the ice/frost ramp at station Xt-1857. The area is shallow and approximately 5-inches long by 3-inches wide.

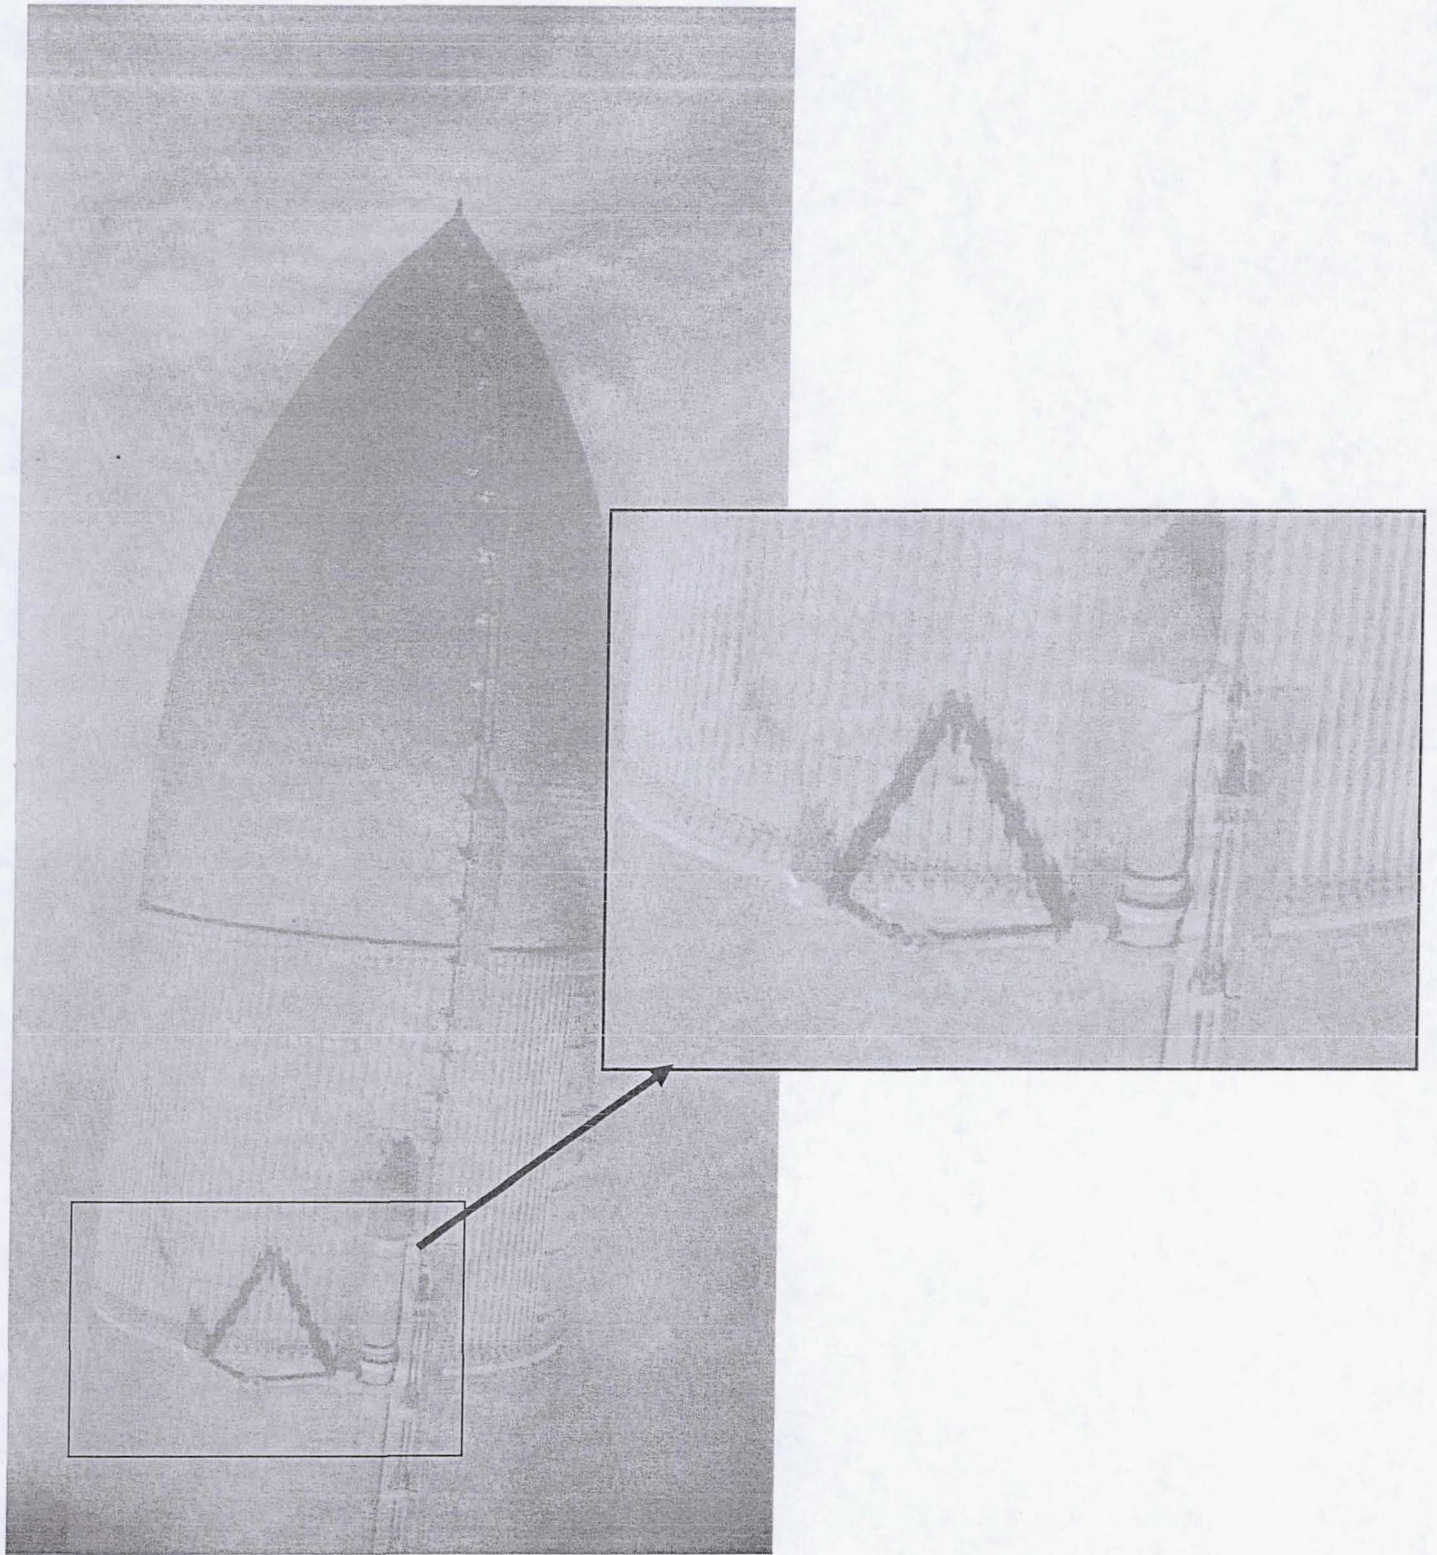
A large portion of the -Y bipod ramp is missing. The bipod spindle housing is exposed. The missing foam is most likely the item seen (E-222) striking the LH ETA ring during ascent.

One TPS divot was observed on the intertank-to-LH2 tank flange closeout near the -Y jack-pad closeout. The divot is approximately 3-inches in diameter and has exposed substrate.

Two shallow divots were noted at the intertank-to-LH2 tank flange closeout. One, approximately 6-inches long and 2-inches wide, was located in between the jack-pad closeouts. The other, approximately 2.5-inches long by 1.5-inches wide, was just forward of the +Y jack pad closeout.

Photo 7: External Tank post separation
View shows portion of -Y bipod ramp missing and three small divots in LH2-to-intertank flange closeout

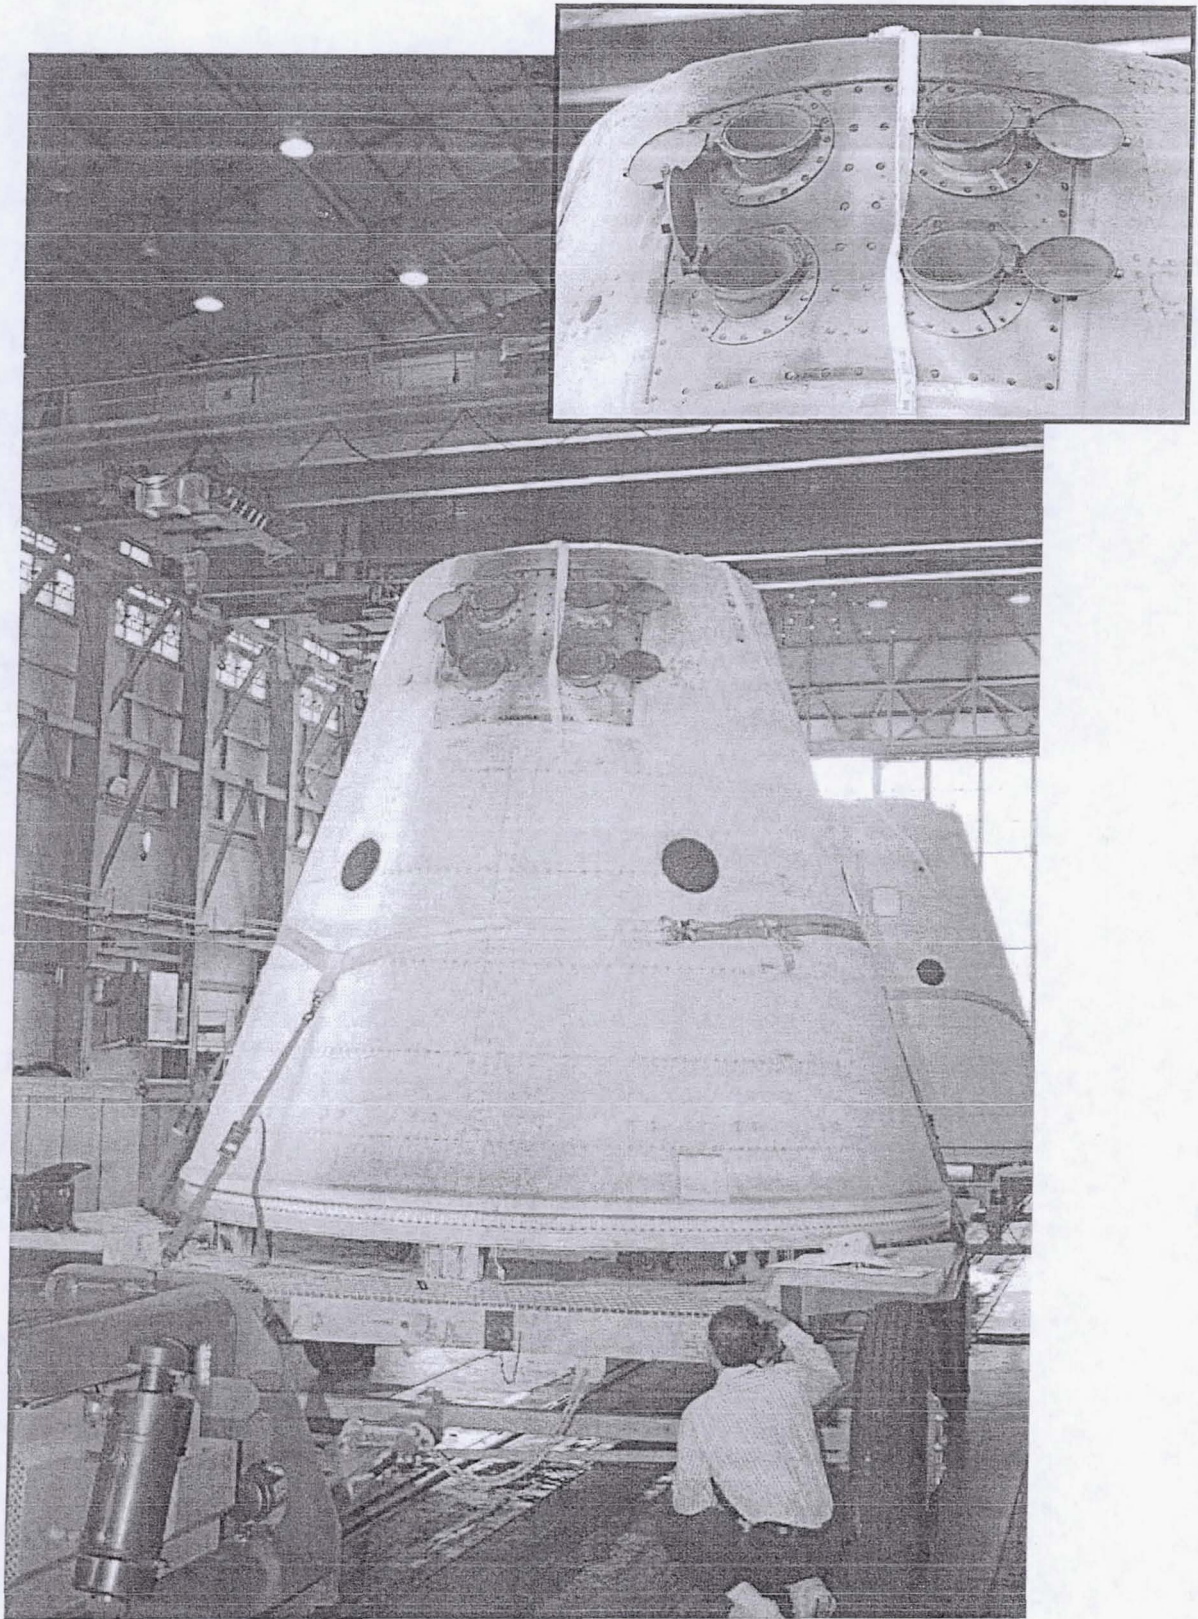
Photo 8: LH Frustum Post Flight Condition

The LH frustum exhibited no debonds/unbonds or missing TPS. All four BSM aero heat shield covers had fully opened and locked, but one cover attach ring had been bent at the hinge by parachute riser entanglement.

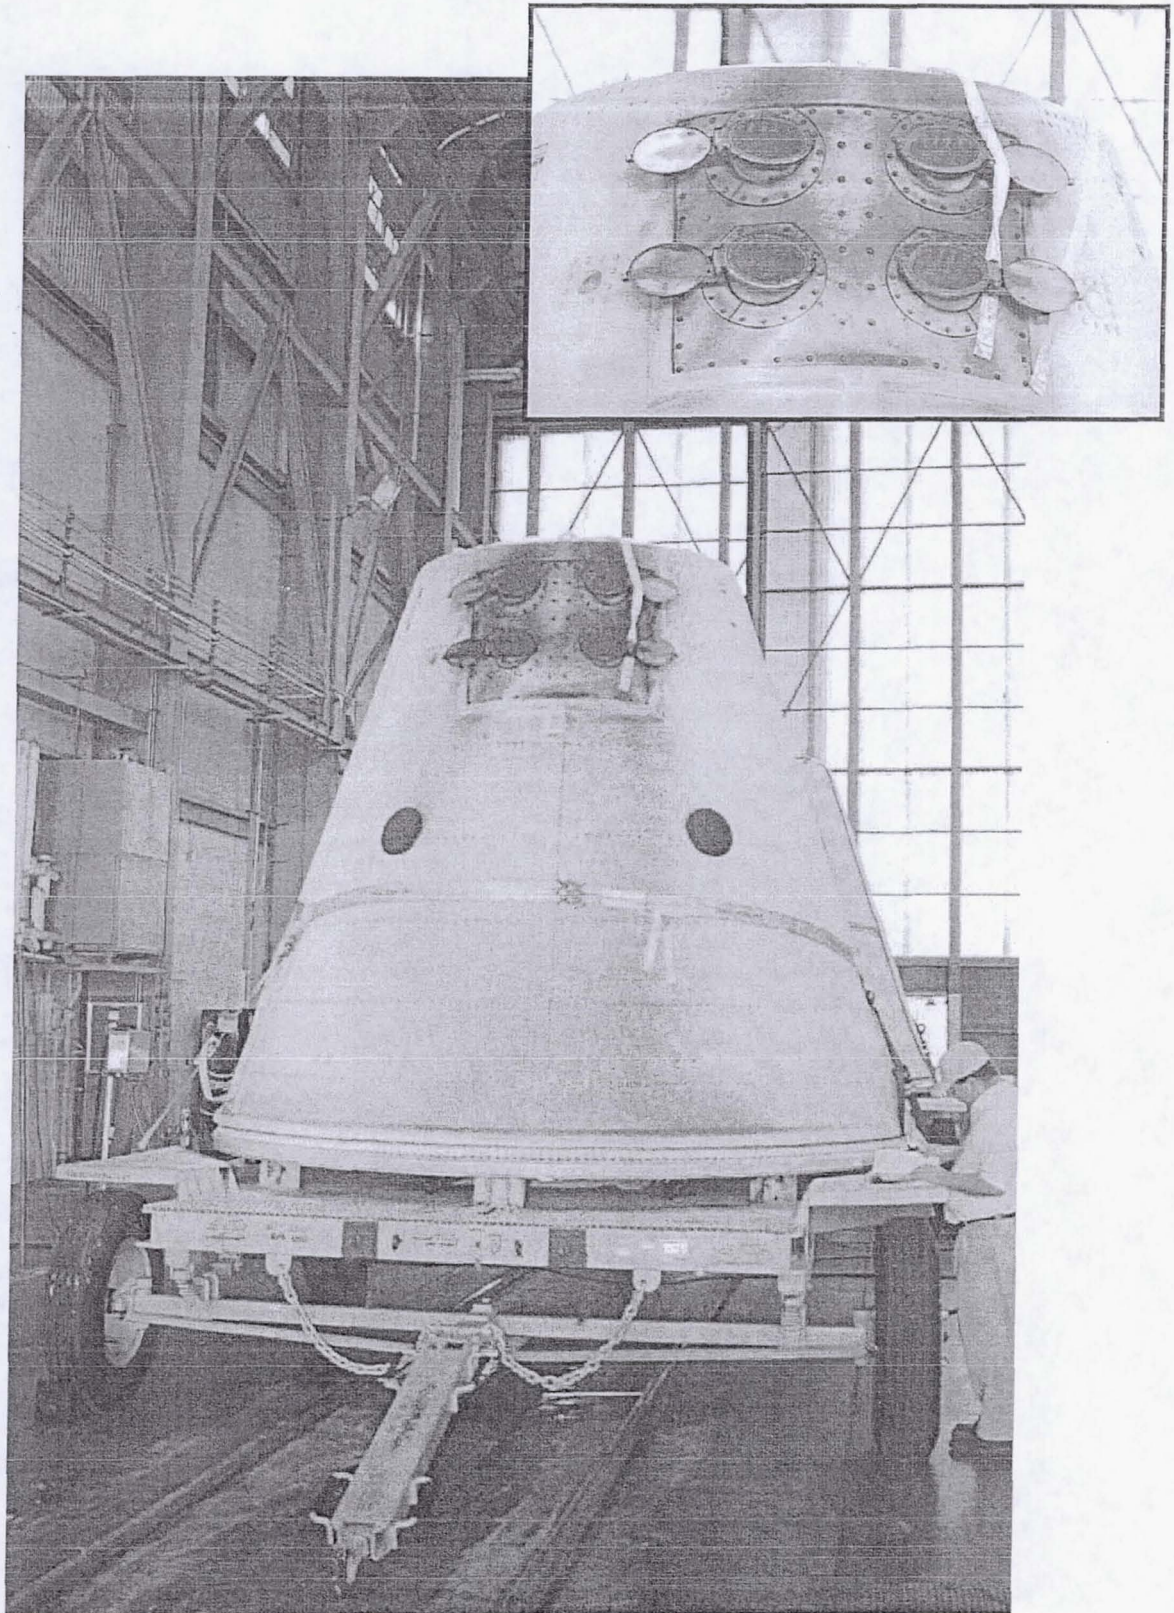
Photo 9: RH Frustum Post Flight Condition

The RH frustum exhibited no debonds/unbonds or missing TPS.
All four BSM aero heat shield covers had fully opened and locked.

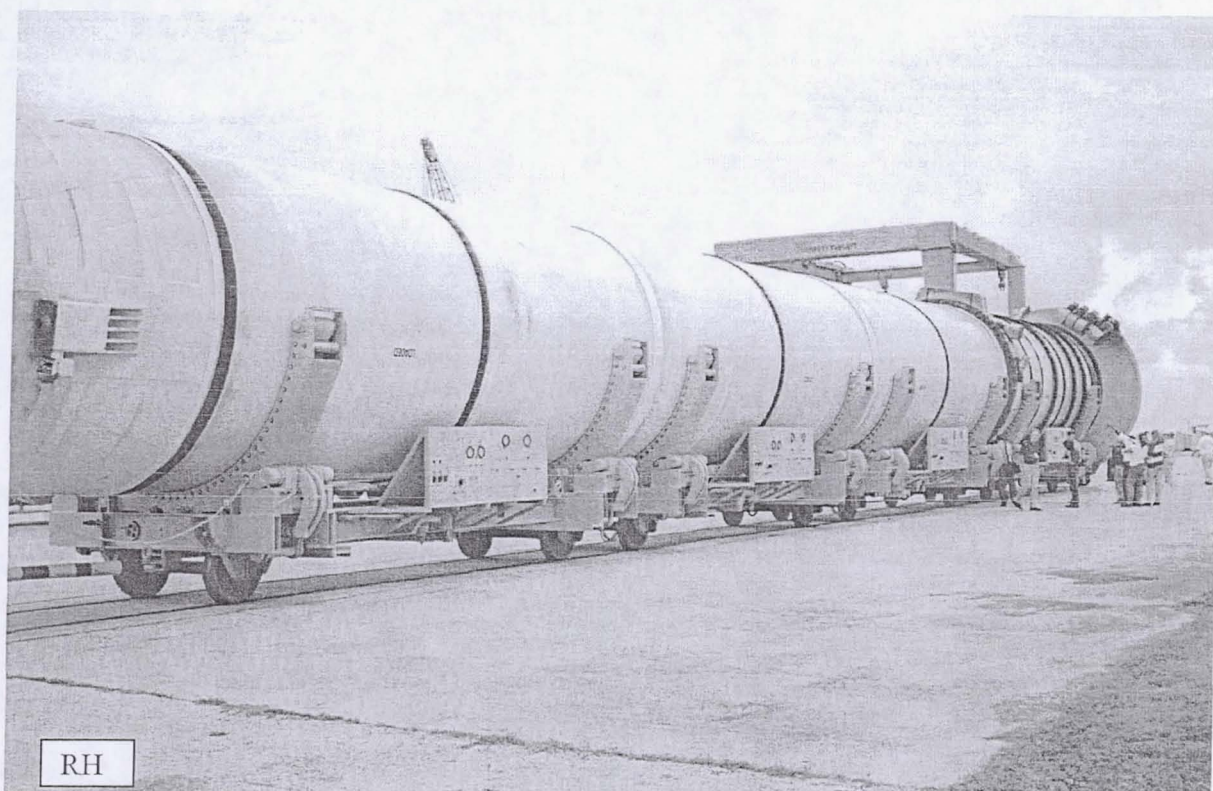
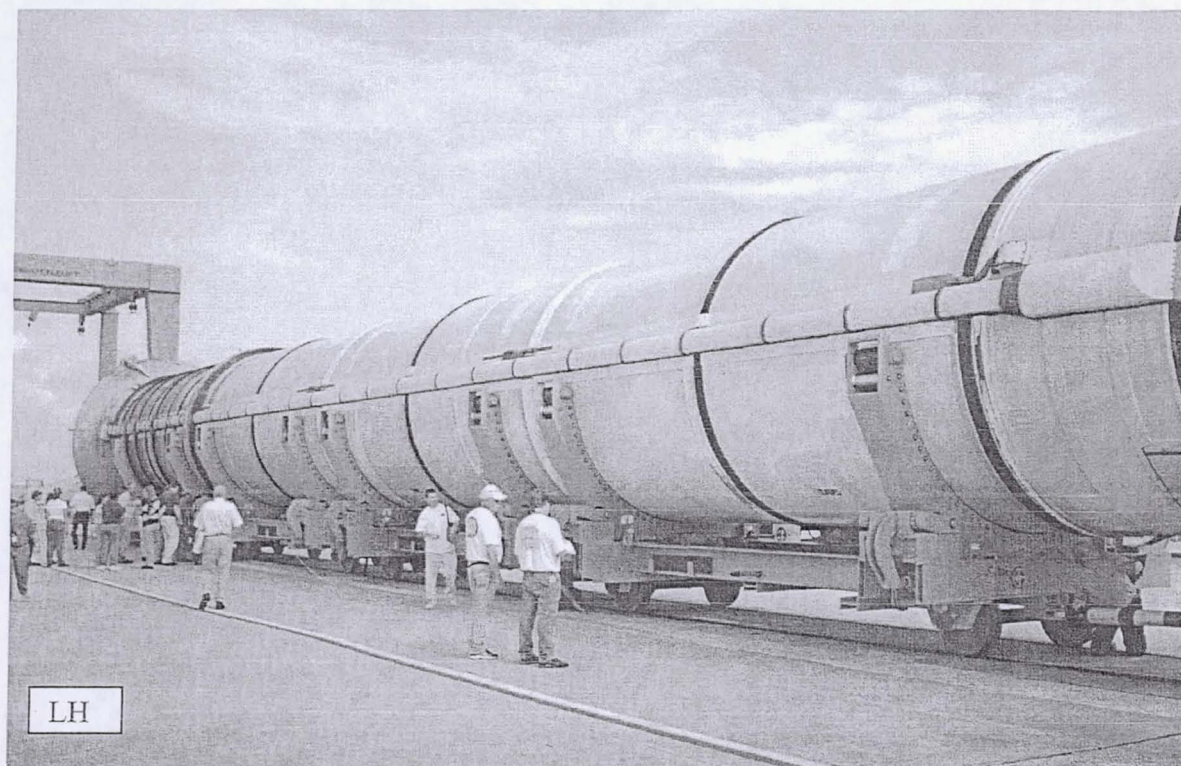
Photo 10: SRB Post Flight Condition

Both SRBs were found in good condition regarding debris assessment

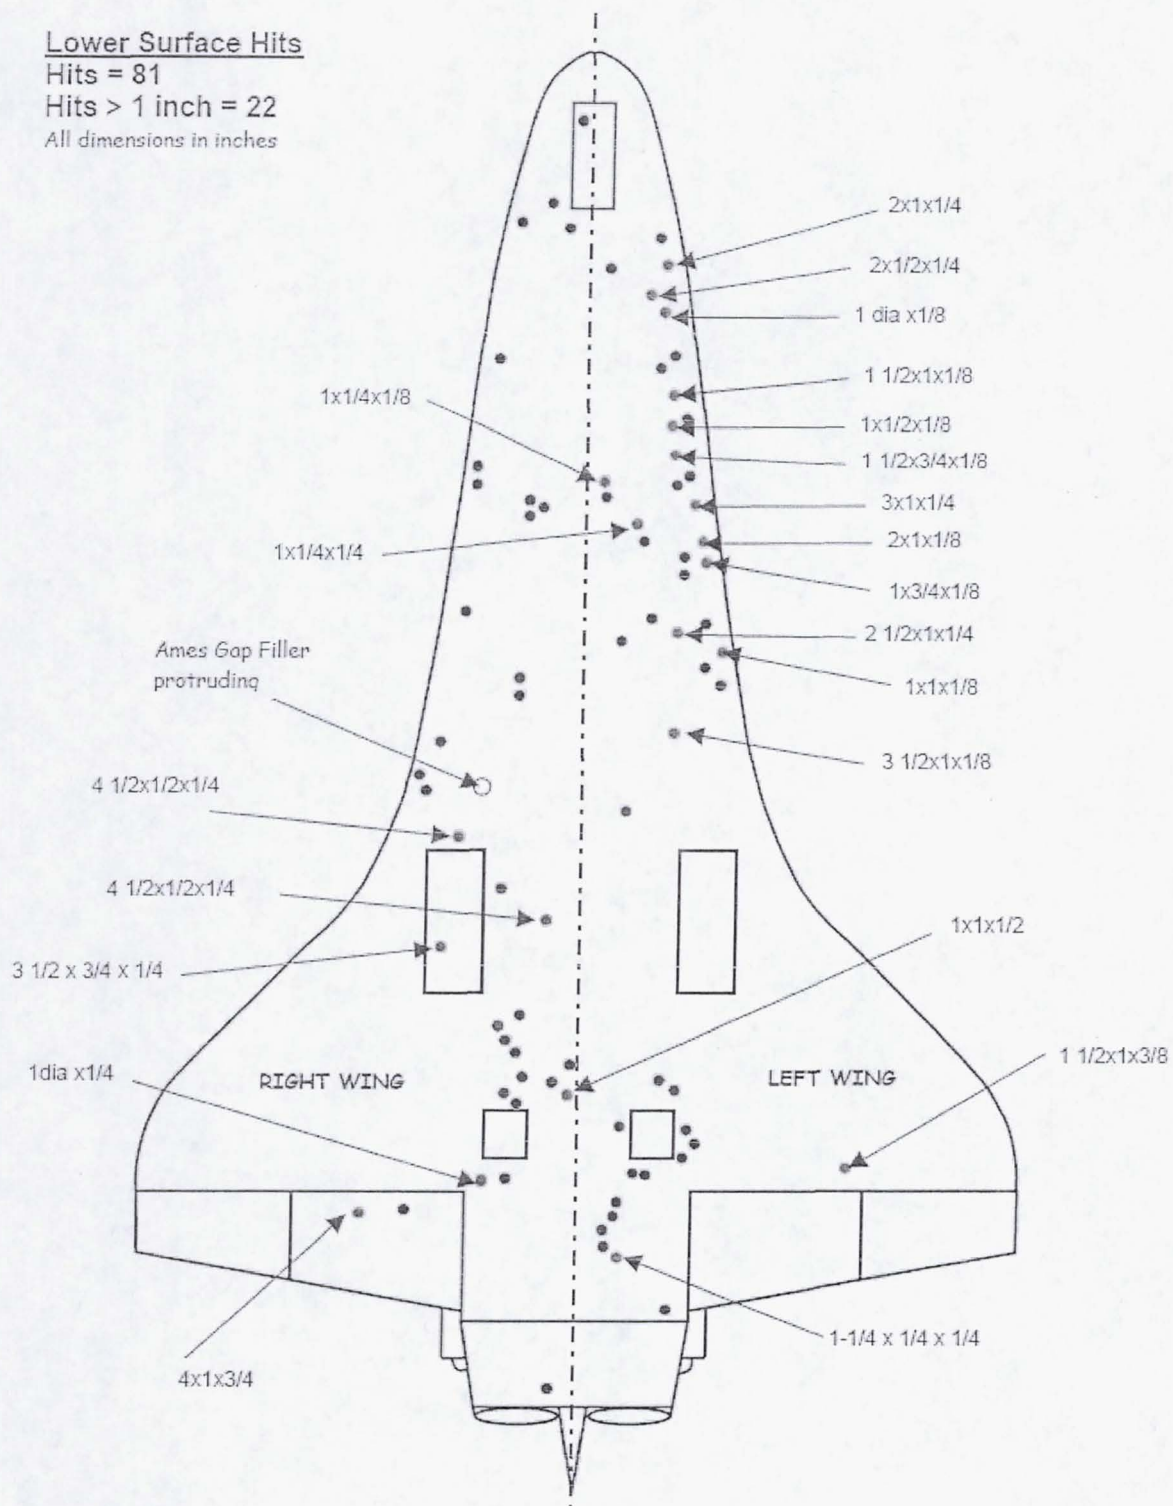
Figure 1: Orbiter Lower Surface Debris Damage Map

The Orbiter lower surface sustained 81 total hits, of which 22 had a major dimension of 1-inch or larger, both numbers are well within family. The majority of the hits were in the area from the nose landing gear to the main landing gear wheel wells. This area sustained 46 hits with 15 greater than 1-inch. Most of the hits in this area are shallow, indicative of damage from External Tank foam.

The largest lower surface tile damage site, located just right of centerline in between main landing gear wheel wells, measured 4-1/2 inches long by 1/2-inches wide by 1/4-inches deep. The cause of this damage was most likely ice/frost from the ET LO2 feedline bellows or support brackets.

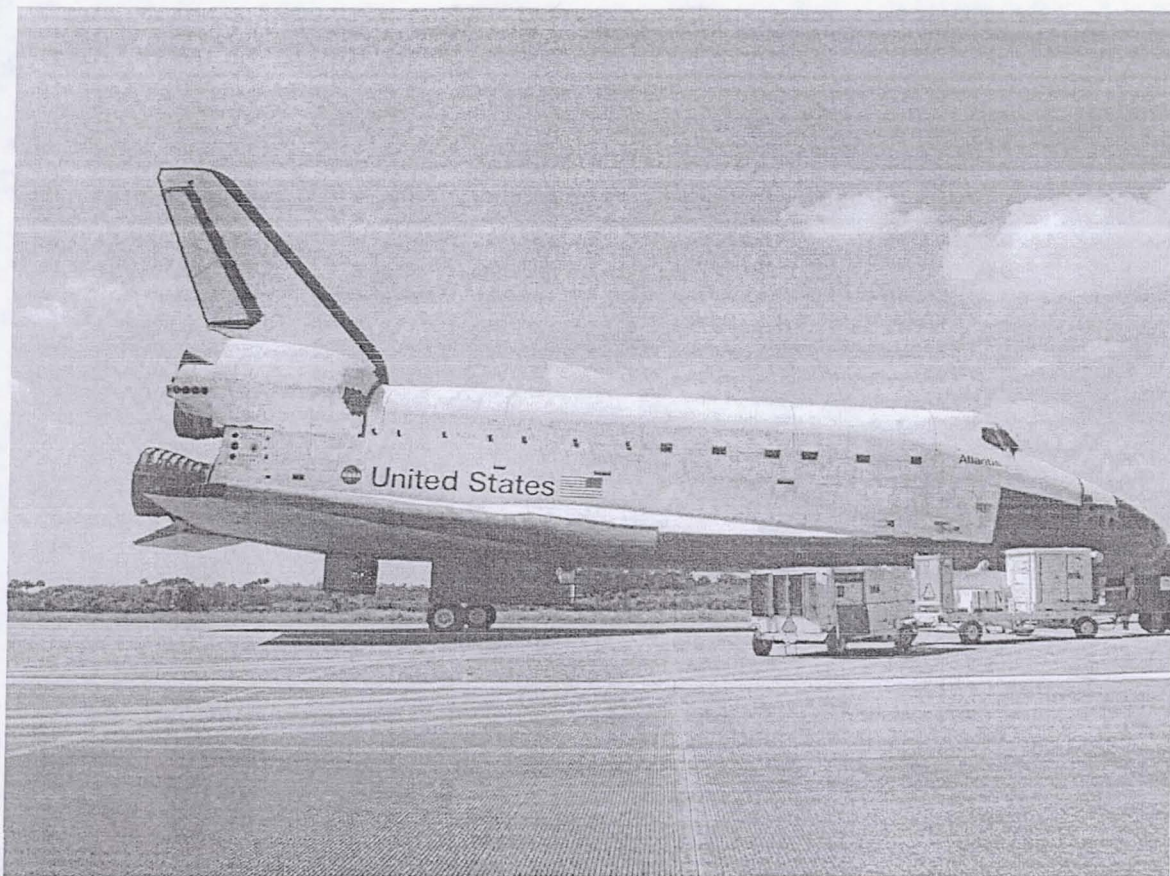
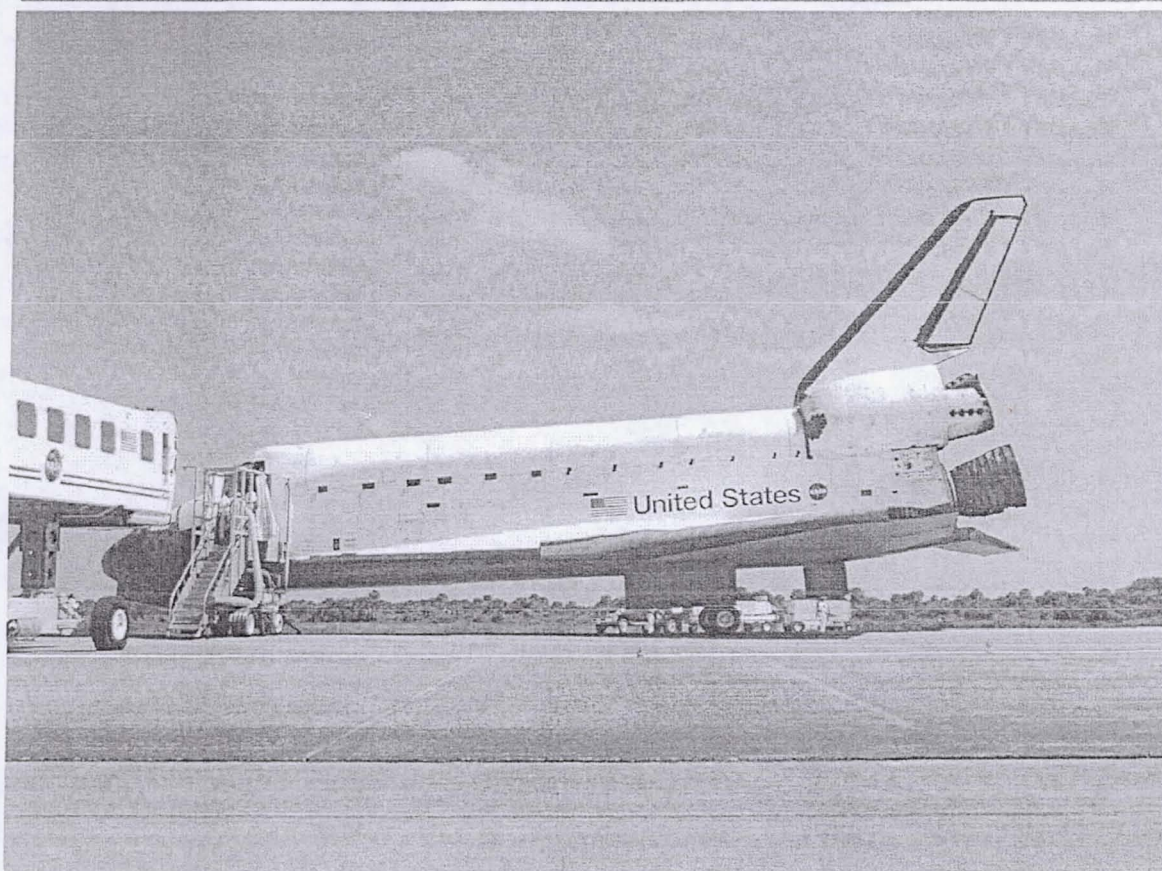
Photo 12: Overall View of Orbiter

The Orbiter TPS sustained a total of 107 hits, of which 25 had a major dimension of 1-inch or larger. Both the total number of Orbiter TPS debris hits and the number of hits 1-inch or larger were within established family.

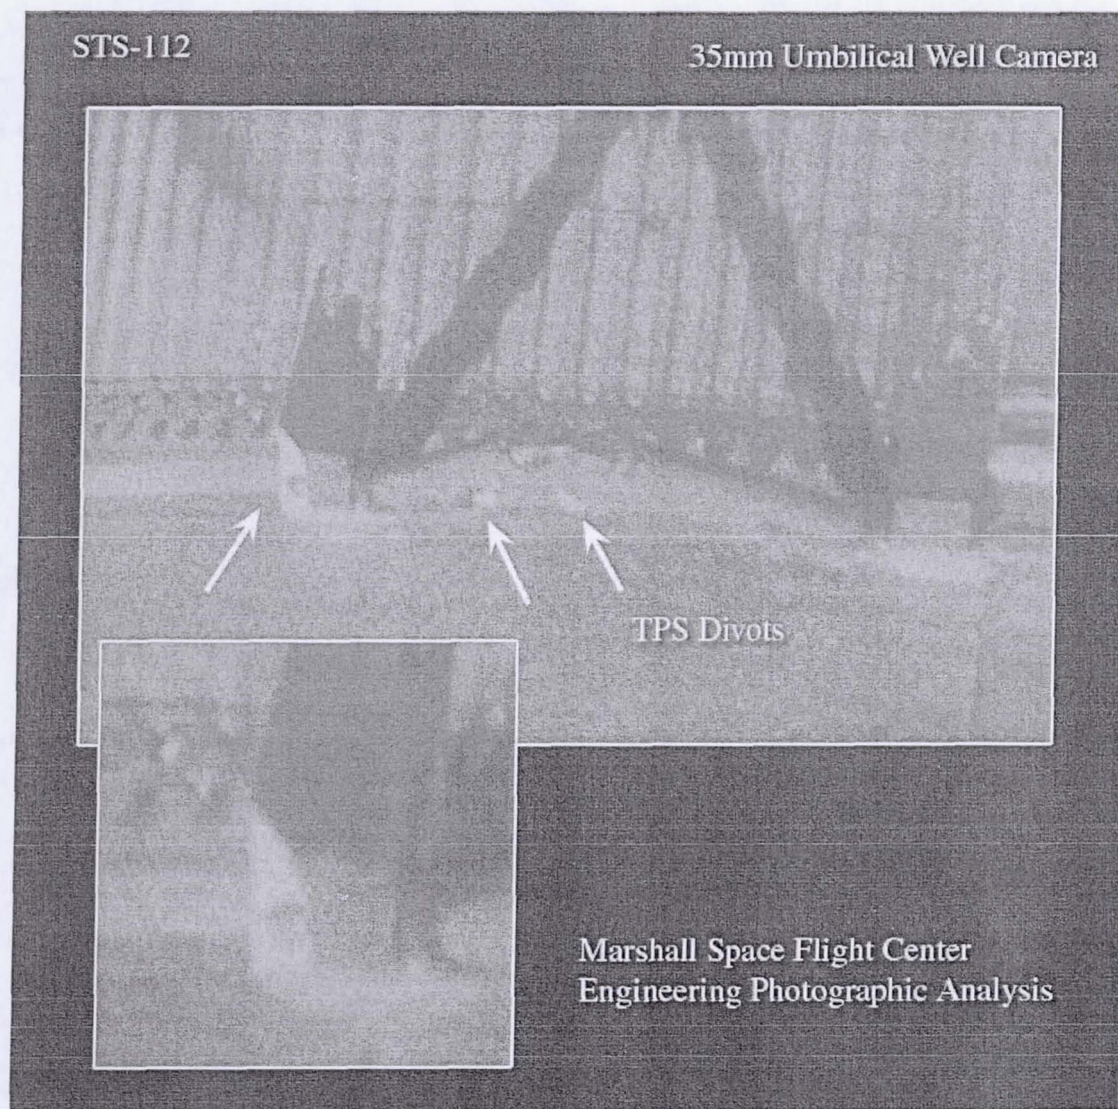
Figure 1. UMB035MM: TPS Divots under Bipod and Bipod Ramp

A large divot is noted on the -Y (left) bipod ramp. A divot of this type has been seen and imaged previously on mission STS-50. This divot appears to be a likely source for the out-of-family observation in which debris impacted the left SRB IEA Box.

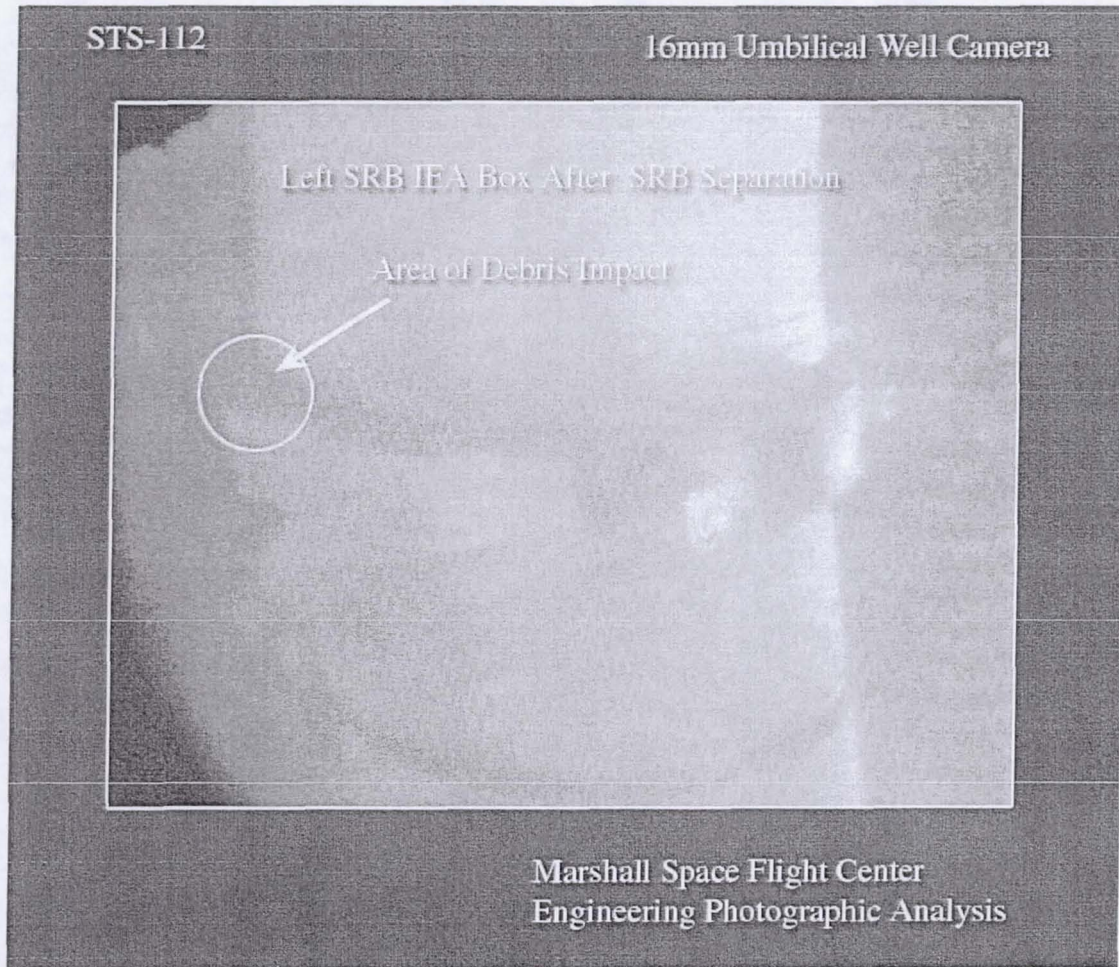
Figure 3. FL101: View of Left SRB IEA Box after SRB Separation

The Left SRB was imaged by the onboard Umbilical Well Camera FL101. In the time period after separation and before the booster drops from view, there were no clear marks on the Left SRB IEA Box area which indicated the debris impact area. From post-launch inspection of the SRB, after retrieval, an area for the impact was determined and is circled in the image.
